AVIATION INVESTIGATION REPORT
A01Q0166

LOSS OF CONTROL AND COLLISION WITH WATER

AIR SAINT-MAURICE INC.
DE HAVILLAND DHC-2 MK 1 C-GPUO
MOLLET LAKE, QUEBEC
08 OCTOBER 2001

Report Number A01Q0166

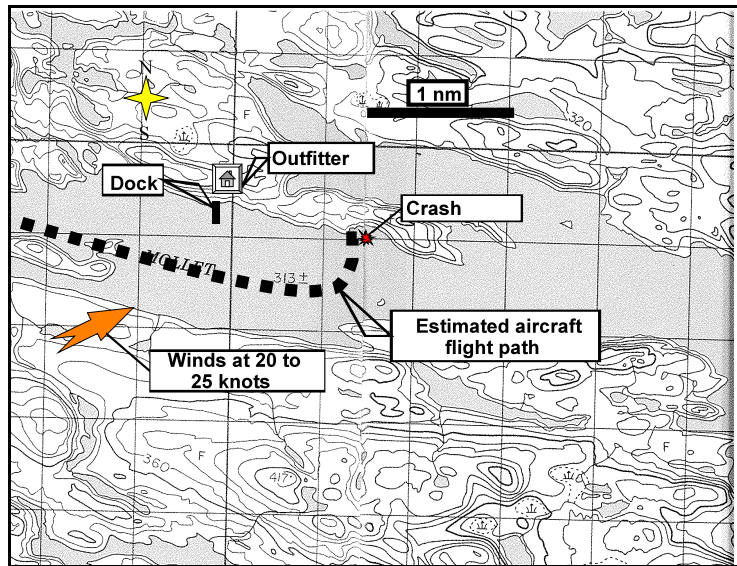
Figure 1. Estimated flight path of the Beaver

The outfitter is located on the north shore of Mollet Lake. The lake is 1 nm wide and is oriented east-west. The aircraft flew the downwind leg, proceeding east along the south shore of the lake. About 1 nm east of the outfitter, at an altitude of about 500 feet above ground level, the pilot made a left turn and proceeded north on the base leg. On approaching the north shore and the rising terrain immediately north of the lake, the aircraft was shaken and then turned right, taking it farther away from the outfitter. Meanwhile, witnesses heard an increase in engine noise. In the turn, the seaplane pitched nose-down and struck the surface of the lake, right wing first. The aircraft crashed 1 nm from the outfitter at about 1735.

The fact that the propeller blades were in the “FINE PITCH” position and that the flaps were extended 30 degrees suggests that the pilot had completed his landing check either on the downwind leg or base leg. At the end of the base leg, the pilot normally should have made a left turn onto the final approach over the lake. But the pilot decided, for some unknown reason, to turn right and move away from the intended landing area. Since the pilot had reported seeing the outfitter a few minutes before, it is unlikely that the weather made him turn right. It is more probable that, on the base leg, due to wind, the descending aircraft drifted faster than the pilot was expecting towards the high ground to the north of the lake and consequently overshot the intended approach track.

In this case, it is possible that a left turn would have resulted in a collision with the terrain feature or placed the aircraft over the terrain at an unsafe altitude or on a track that would preclude a stable approach. On the other hand, a 270-degree right turn would allow the pilot to keep the aircraft over the lake, avoid all obstructions, and make a stable approach. However, the right turn put the aircraft on a downwind track at low altitude in a situation conducive to illusions created by drift. It is possible that, due to the effects of wind, the pilot adopted a steep bank to counteract drift; this manoeuvre, which increases vertical speed, may have brought the aircraft close to the surface of the lake, forcing the pilot to raise the nose and increase power. Although extending the flaps increased wing lift, it also increased aircraft drag; therefore, the increase in power was not felt as quickly as with the flaps retracted. Also, it is reasonable to believe that the conditions at the time of the accident were conducive to contamination of the flight surfaces of the Beaver, because the two Cessnas reported icing after flying in snow showers. The combined effect of contamination of critical surfaces and the turn increases the stall speed. Therefore, the stall can be attributed to the combination of all these factors, which eliminated the gap between the speed of the aircraft and the stall speed in a situation conducive to illusions created by drift.
